# Drones Enhancing SPCC Planning

## High-Resolution Aerial Data Collection

### Drones to Augment SPCC Plan Update

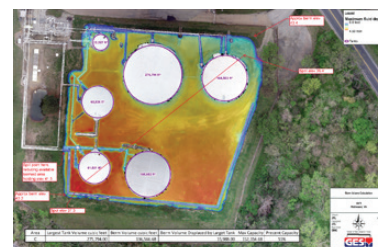
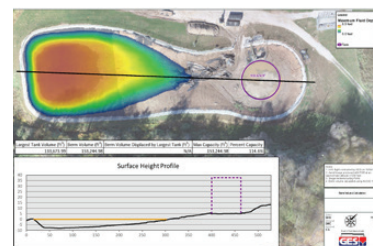
Berm Modification After demolition of an AST, GES' client began planning for tank replacement, and noted persistent standing water within the spill containment berm resulting from topography and stormwater management practices. GES performed a drone flight, in place of traditional ground-based methods, to document site topography and calculate the secondary containment volume. Our visualization tools allowed us to account for the loss of secondary containment capacity due to the chronic standing water in the bermed area along with the new AST and tank pad. GES was able to determine the minimum berm height required to ensure compliance with the federal SPCC requirements.

During a routine SPCC plan update for a client's site, GES used a drone in place of traditional methods to measure the secondary containment berm. Using the drones combined with photogrammetry software, a highly-accurate 3D digital elevation model of the site was generated, allowing engineers, GIS specialists, and CAD drafters to simultaneously assess the parameters of the berm. The berm was found to be out of compliance due to previous inaccurate field measurements, grade of the spill surface, and degradation of the berm since the last inspection. Using our 3D model, we provided minimum elevations of the berm to optimize: 1) effectiveness for spill containment; and 2) adjustments for stormwater runoff from parking drainage. GES provided the client with an updated aerial map and accurate digital site documentation to assist with addressing facility deficiencies.
